MISCELLANEOUS PAPER SL-79-20

THE STRUCTURAL AND DURABILITY PROPERTIES OF VARIOUS CONCRETE REPAIRS

Carl E. Pace

September 1979

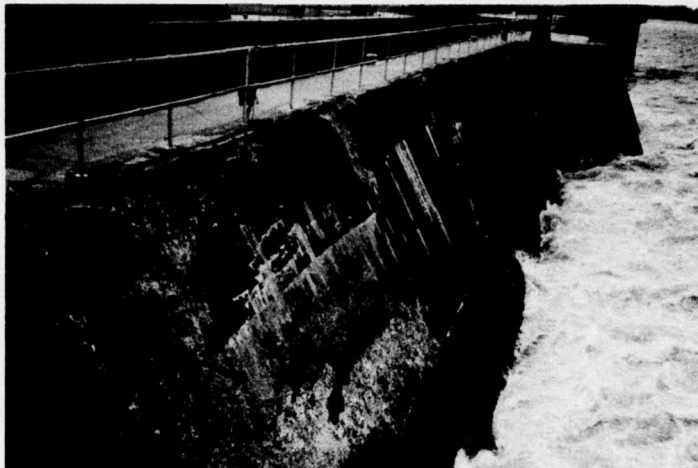
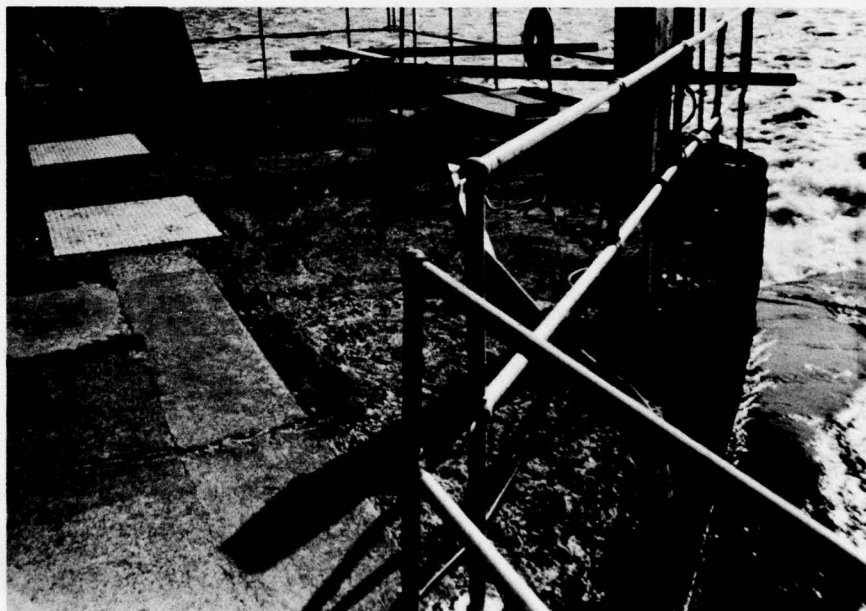
Figure 1. Deteriorated surface concrete,
Troy Lock and Dam, Hudson River,
Troy, New York

3. A few examples of deteriorated locks and dams are given in Figures 1 through 7.

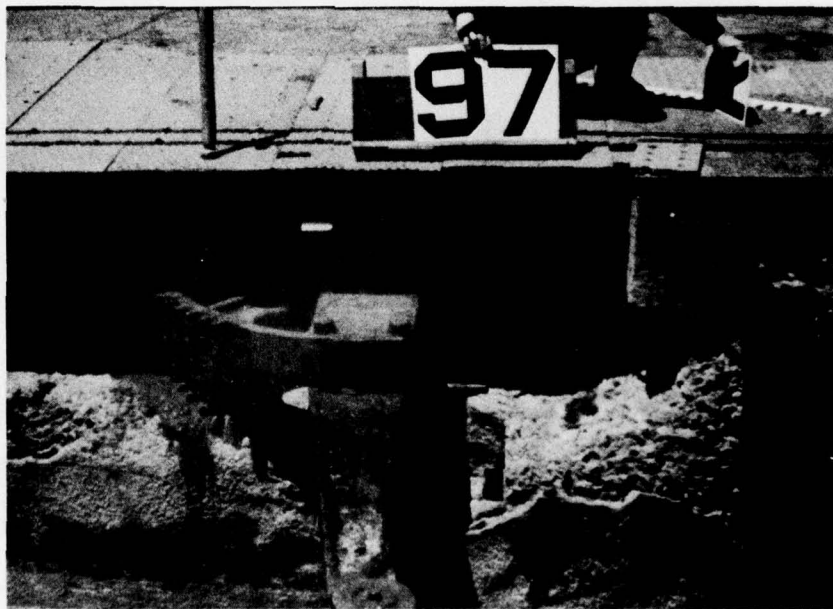
a. Emsworth Lock, Ohio River, Pennsylvania

b. Lock and Dam 3, Monongahela River, Pennsylvania

Figure 3. Deteriorated gate anchorage

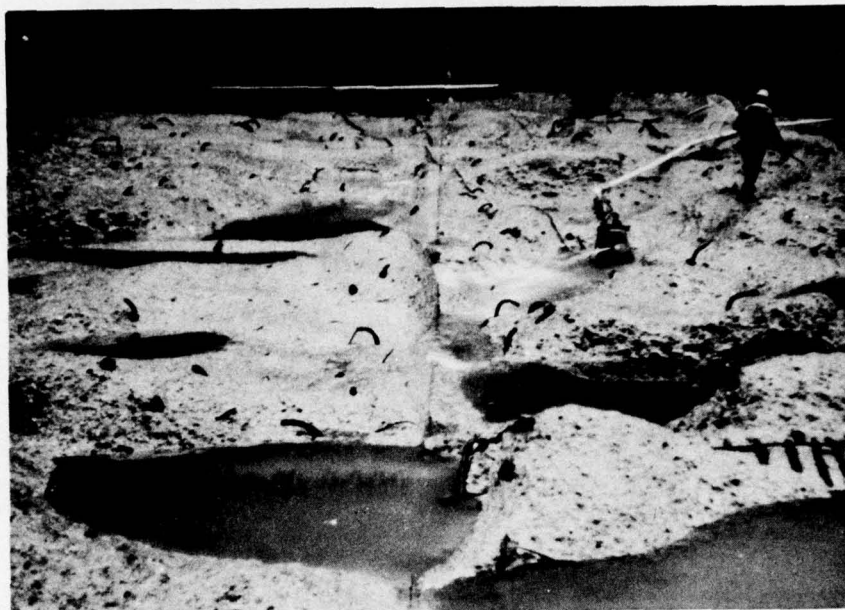
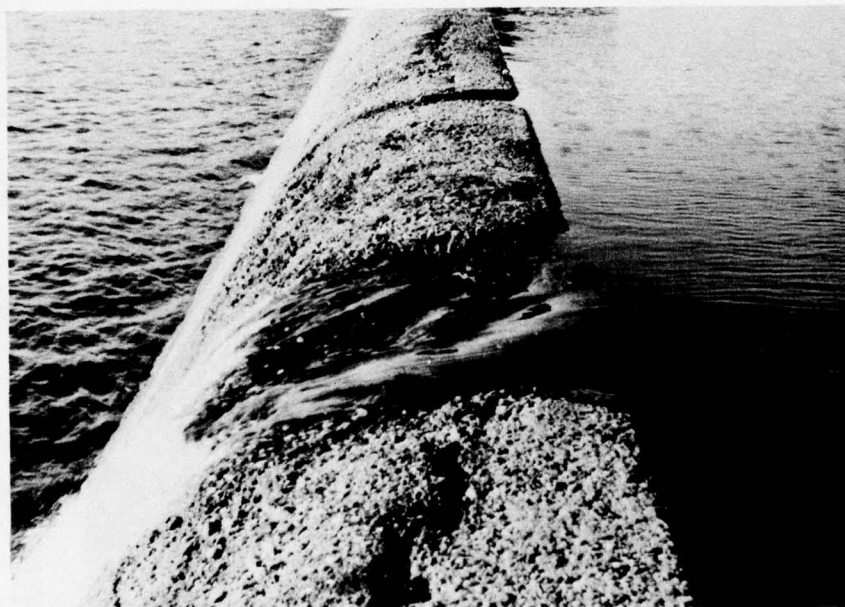
a. Stilling basin erosion, Libby Dam, Libby, Montana

b. Dam surface erosion, Troy Dam, Troy, New York

Figure 5. Eroded concrete surfaces

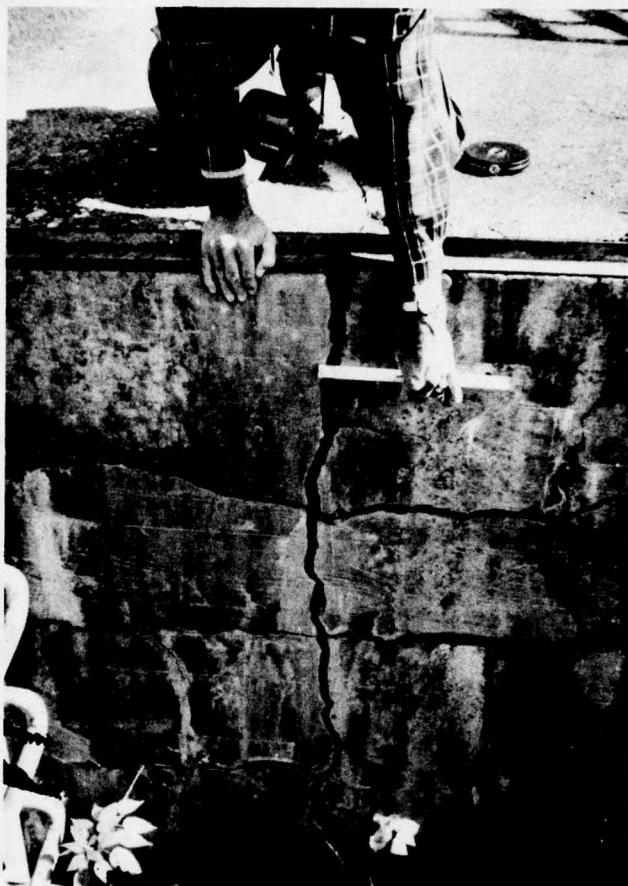
Figure 7. Cracked lock wall, Oliver Lock,
Tuscaloosa, Alabama

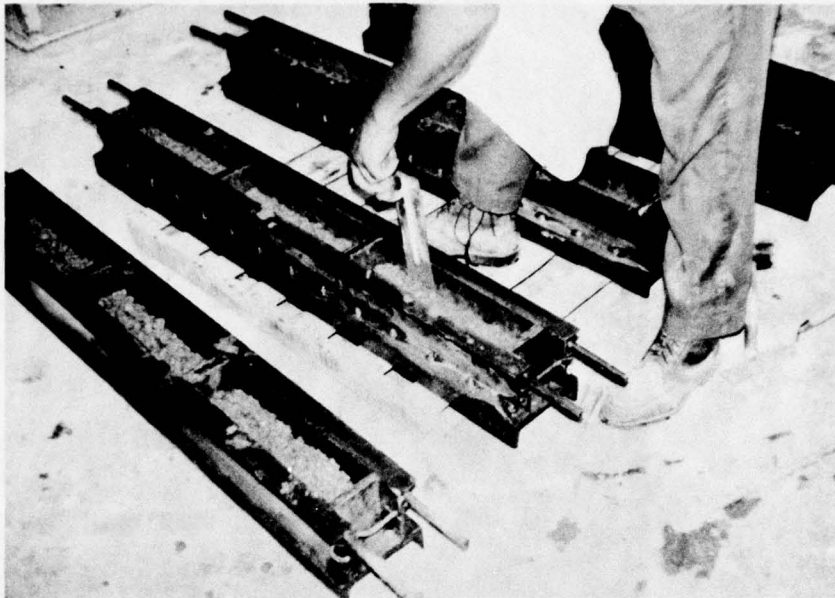
a. Consolidation of first placement

b. Finishing of first placement

Figure 8. First placement of specimens to evaluate overlay performance
